GEOTECHNICAL STABILISATION OF PILE ARISING

An extension to an existing large water treatment works. The main contract consisted of sinking over 100 piles 25 meters into the ground to form the outer wall of a foul water storage tank. UK Remediation were tasked with making the saturated arisings stable for road transport and safe disposal.

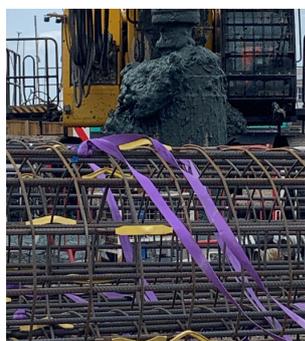
Figure 1 – Piling rig bringing wet material to the surface

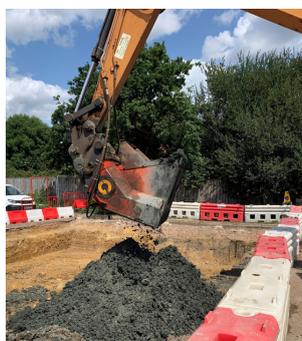
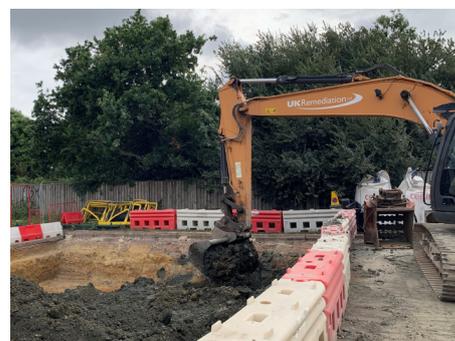
Figure 2 – Drying agent added using a specialist excavator processing bucket attachment and sealed to allow time to cure.

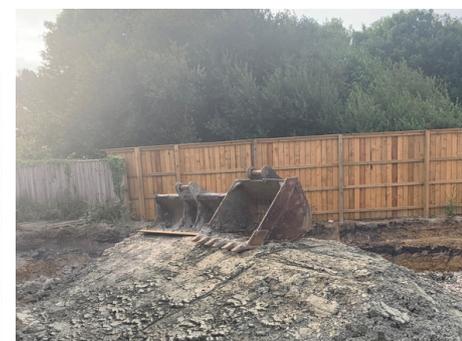
Figure 3 - Stabilised material able to bare weight post treatment and ready for disposal.
