Case Study

Onsite Treatment and Disposal of Asbestos and Coal Tar Contamination

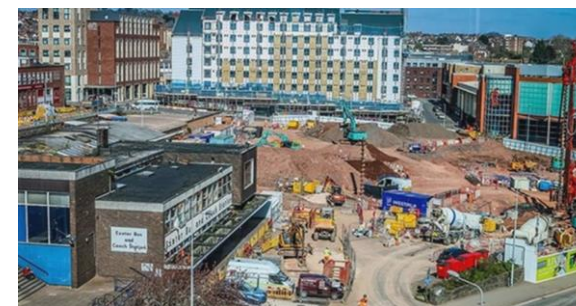
Busy city centre site: Remediation works visible at rear

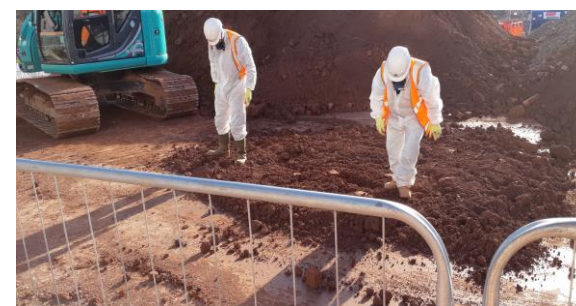
Small batch picking of asbestos within the controlled area

- Excavation and disposal of coal tar bound asphalt as hazardous waste prior to main works.
- Establishment of controlled quarantined area.
- Treatment of a total of 4,600 tonnes of asbestos fragment containing soil, using physical processing to allow specialist operatives to handpick visible asbestos.
- Waste assessment of treated material to confirm the absence of asbestos enabled formerly Hazardous material to be removed from site as Inert. This resulted in a saving of £140,000.
- UK Remediation undertook site environmental monitoring throughout to provide a strong evidence base for effective health controls.
- Validation sampling of all remediation excavations to confirm the absence of contamination.
