LARGE SCALE REMEDIATION & MANAGEMENT OF ASBESTOS IMPACTED SOILS

Derelict former industrial site used as an informal public recreation area, under redevelopment as a regional energy from waste facility with landscaped public open space and multi-use trackways.

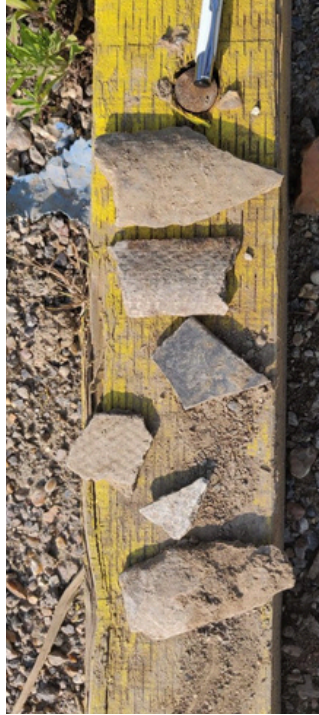
Typical asbestos recovered from site.

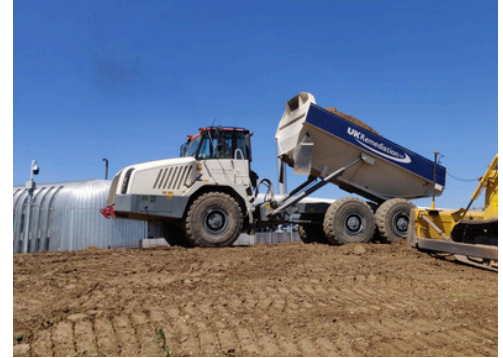
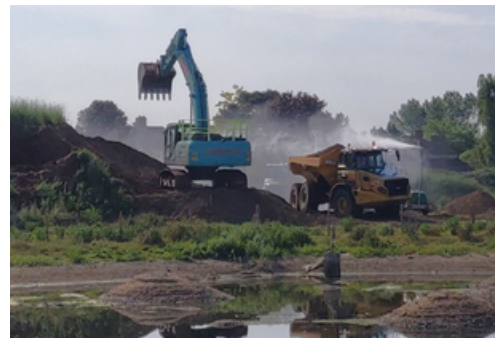
Dust suppression applied whilst working close to a nature conservation area.

- Mobile and fixed dust and odour suppression was deployed.
- Comprehensive air quality monitoring programme with daily and weekly reporting to regulator agreed action levels.
