# MOD PORTSMOUTH DEMOLITION, REMOVAL, REMEDIATION & LANDSCAPING

UK Remediation Ltd

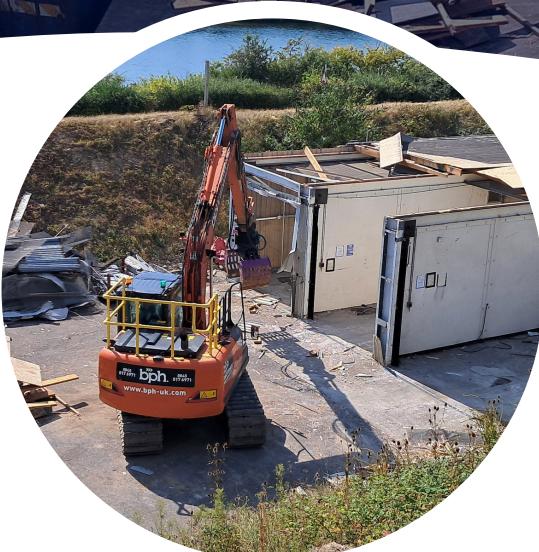
*View of magazine building being demolished from the height of the traverse.*

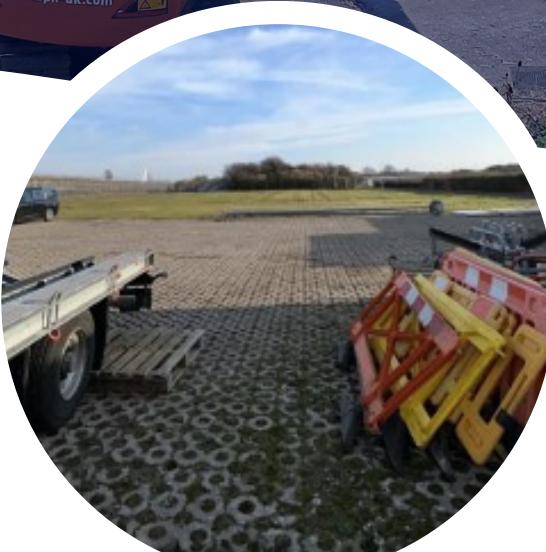
*Winter germination mix showing rapid growth of sward*

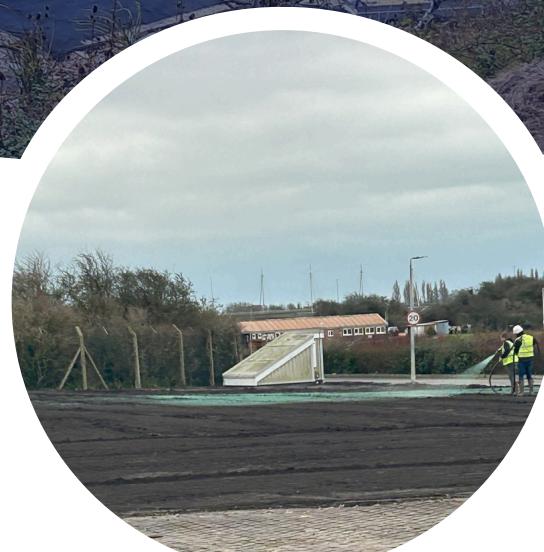
*Hydroseeding in progress (green dye shows where applied)*

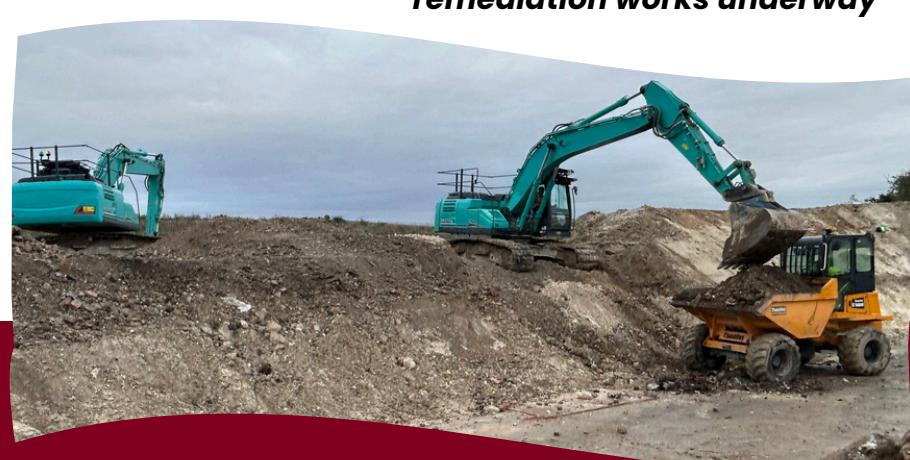
*View of traverse with remediation works underway*

Naval base with a defence diving school and fire training facility adjacent to Portsmouth Harbour. The traverse surrounded a magazine building previously used for storage of explosives. The traverse comprised demolition rubble and reworked natural soils known to contain hazardous asbestos and coal-tar-bound asphalt fragments. Scope of works included: site investigation and delineation, demolition of magazine building, removing contaminated material, constructing and landscaping of the final landform. Key practices throughout included management and monitoring of hazards, validation testing, waste management reporting and carbon accounting.
