# REMEDIATION OF FORMER PAPER MILL

- 14,000m<sup>2</sup> site, with river frontage, on the outskirts of Bristol, undergoing redevelopment for 140 houses. A paper mill, foundry and workshops had operated on the site for over 150 years.

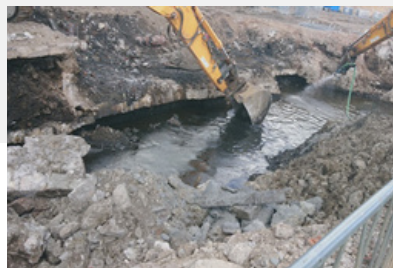
Figure 1 - Flocculant addition to hydrocarbon impacted organic sludge to dewater for handling before further ex-situ treatment.

- Removal of obstructions, including a 100m tunnel to 5m deep, 25 concrete tanks and deep foundations.
- Dewatering and stabilisation/solidification of oil contaminated organic sludge to meet site environmental and geotechnical specifications.

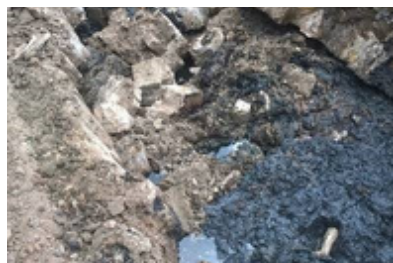
Figure 2 - Hydrocarbon impacted organic sludge.

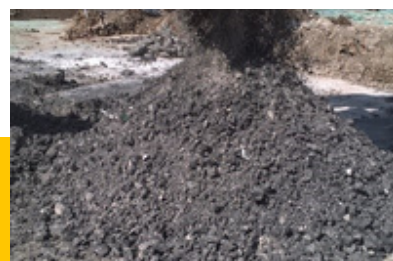
Figure 3 - Dewatered in situ and then remediated using a stabilisation/solidification process
